# LiDAR-Based Landslide Inventory and Susceptibility Mapping, and Differential LiDAR Analysis for the Panther Creek Watershed, Coast Range, Oregon

A thesis submitted in partial fulfillment of the  
requirements for the degree of

Master of Science  
in  
Geology

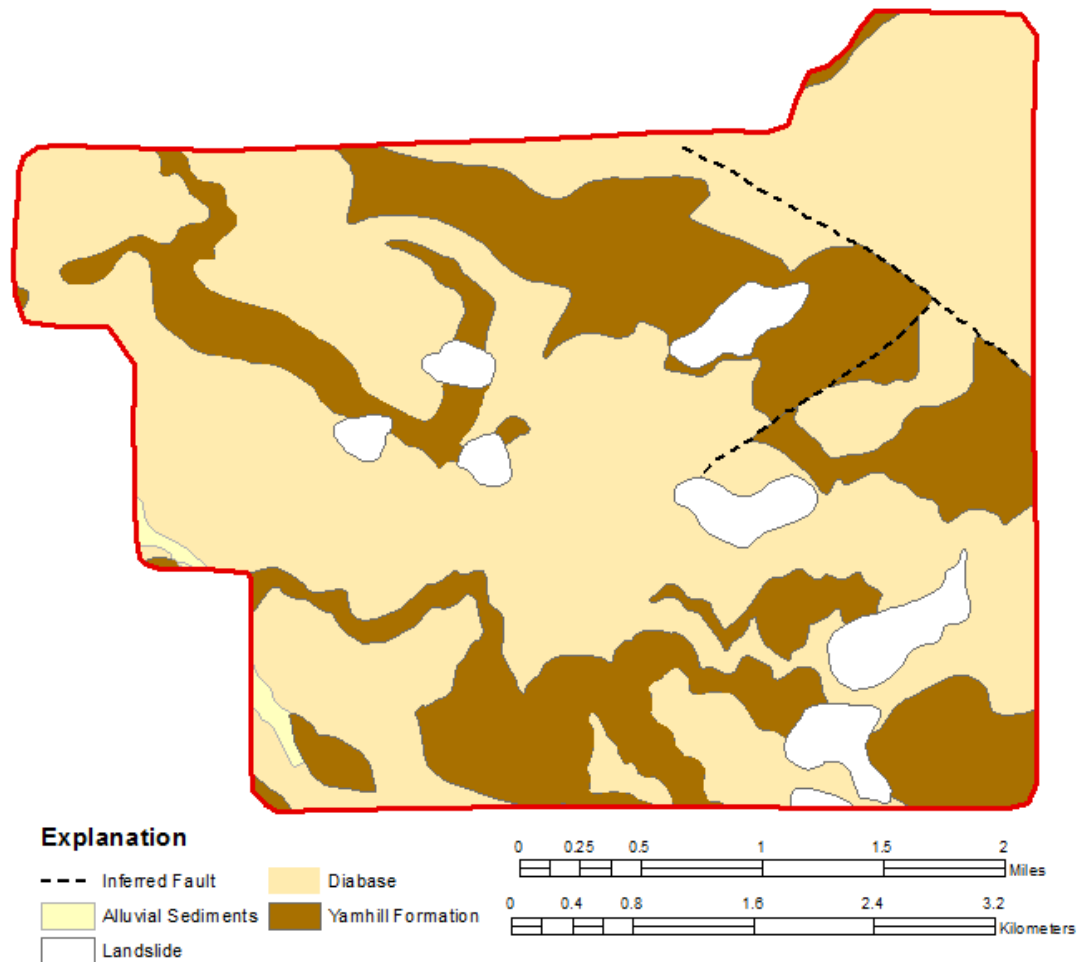
**Figure 4. Geology of the Panther Creek study area (Wells et al., 1994).**

The geology consists of Upper Middle Eocene Yamhill Formation and Upper Eocene diabase (Figure 4). The regional diabase sill complex is aphyric to plagioclase-phyric with zeolite vesicle fillings (Wheeler et al., 2009). The diabase forms sills with well-developed columnar joints and intrudes the overlying deep-marine strata of the Yamhill Formation (Wells et al., 1994). The contact between the diabase and the Yamhill Formation is poorly exposed beneath thick colluvium of weathered diabase and

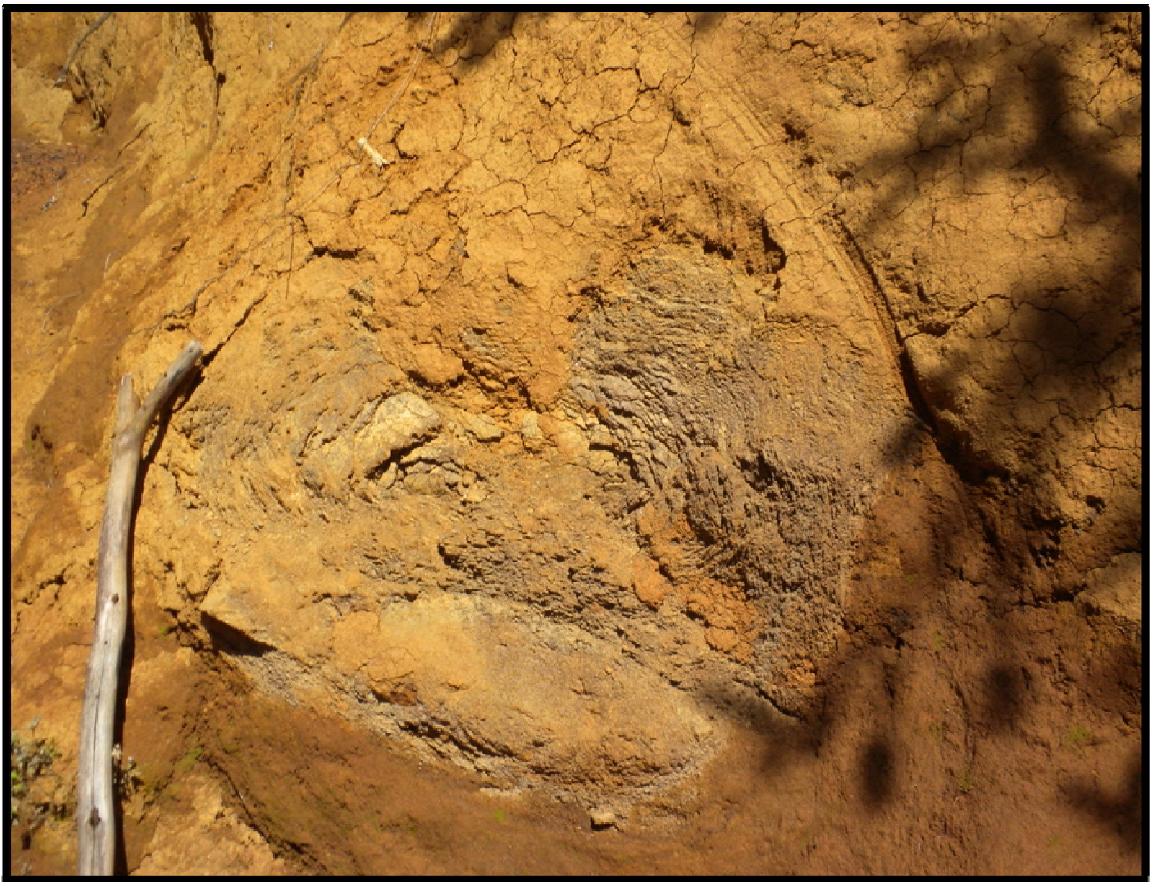
**Figure 5. Spheroidal weathering in the diabase.**

sedimentary rocks. The diabase tends to weather to a reddish-orange, clay-rich soil commonly experiences spheroidal weathering (Wheeler et al., 2009) (Figure 5).

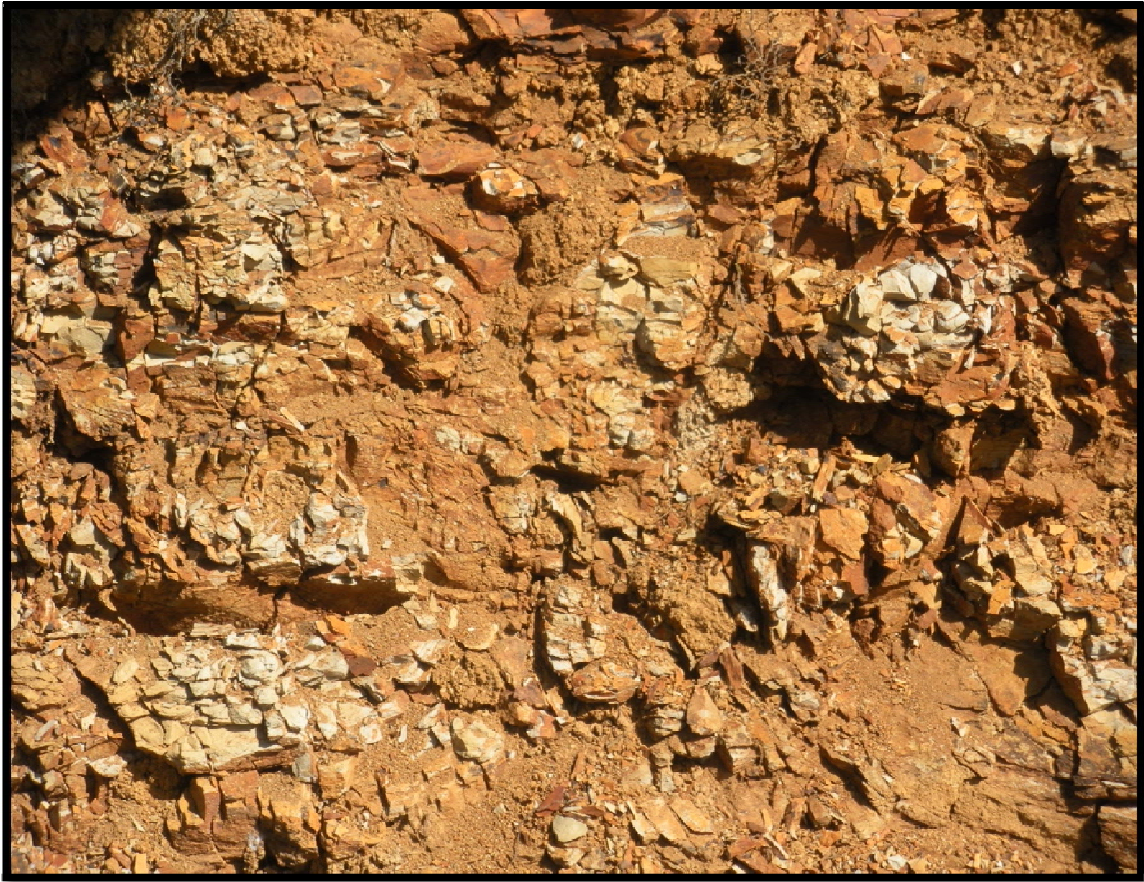
**Figure 6. Siltstone of the Yamhill Formation.**

dominant unit within the study area (Figure 6). The shale and siltstone are overlain by 150 m (500 ft) of thick-bedded fossiliferous sandstone (Orr and Orr, 1999). The sandstone beds are described as arkosic, basaltic, or glauconitic (Snively et al. 1969). The middle and upper part of the section is described as micaceous, thin-bedded sandstone which is about 1,220 m (4,000 ft) thick (Orr and Orr, 1999). Near the top of the section the Yamhill Formation is interbedded with submarine basalt lapilli breccias of the Upper Middle Eocene Tillamook Volcanics (Wells et al., 1994). The sandstone and Tillamook Volcanics are not found in the study area.

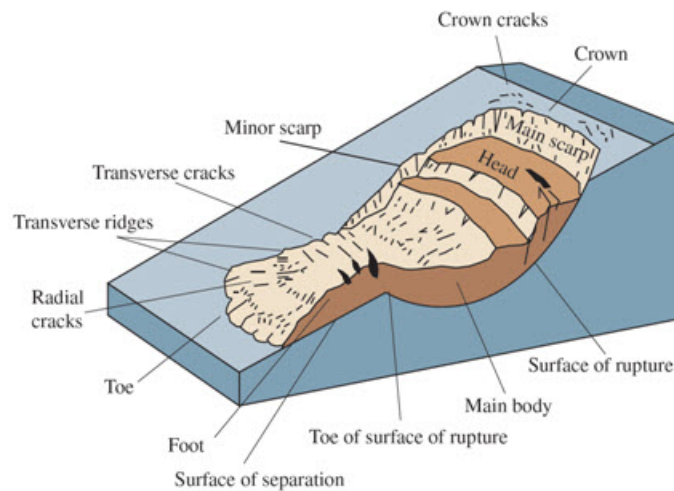
**Figure 7. Block diagram of a complex landslide showing common features. For the landslide inventory the main scarp, minor scarps, and main body were mapped (from Burns and Madin, 2009; modified from Highland, 2004)**

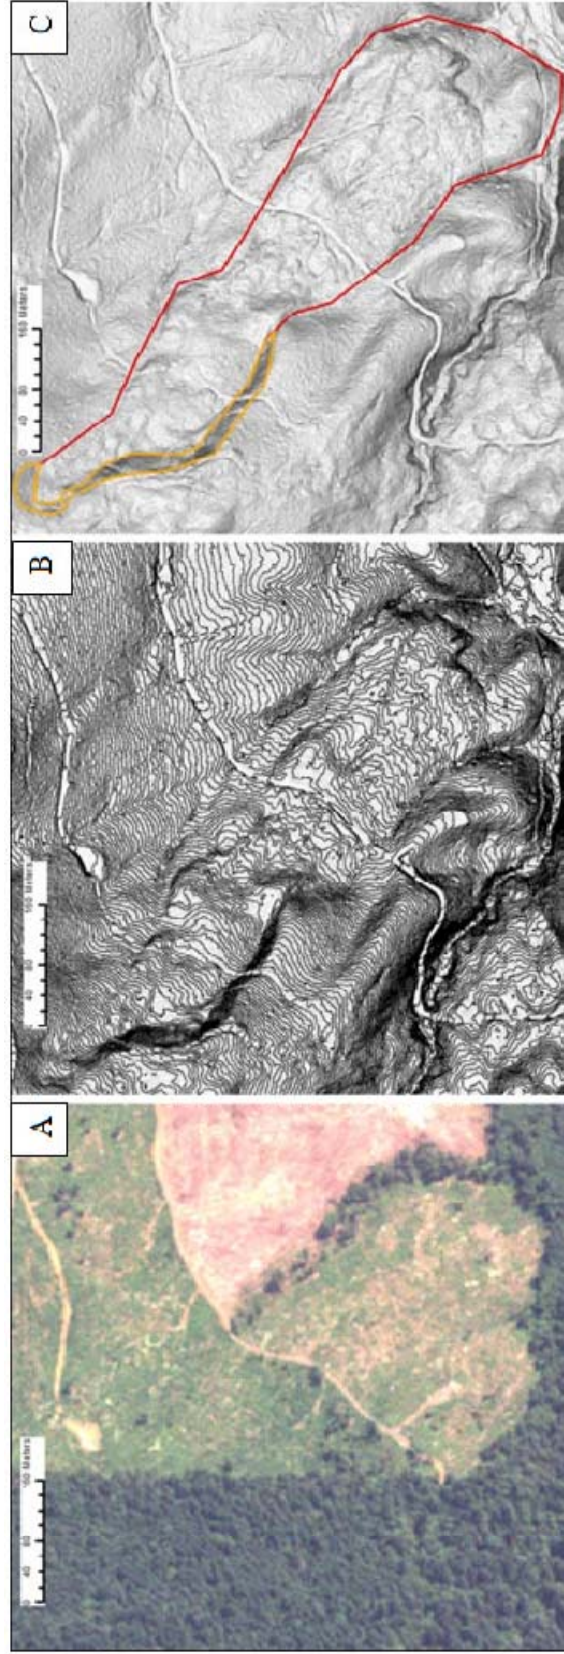
Figure 8. Landslide inventory mapping showing three images of the same area. (a) June, 2008 Quickbird image. (b) LIDAR derived slope map with 1m contours (c) Landslide deposit mapped in red and landslide flanks and scarp mapped in orange

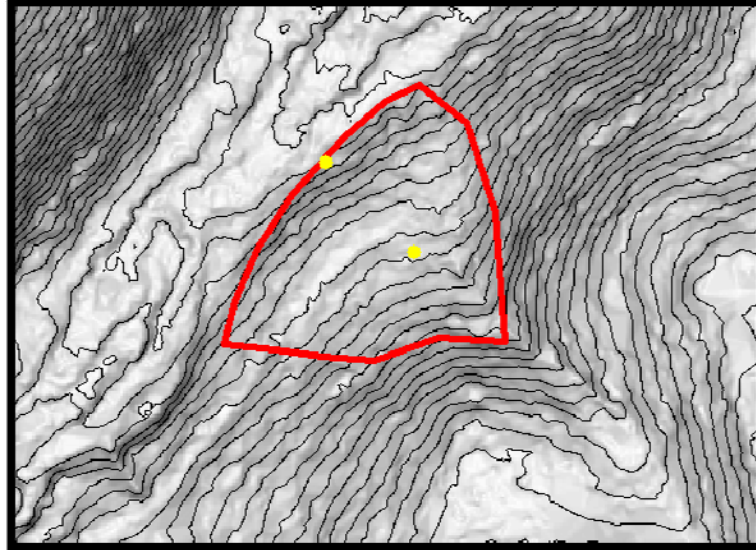
**Figure 9.** Estimated maximum debris flow fan height is the elevation difference between two points on the top and bottom of the fan. Example measurement locations are shown by the yellow dots (Burns and Madin, 2009).

The slope angle (degrees), head scarp height (m) and fan height (m) were measured using the LiDAR-derived slope map and the LiDAR DEM. The head scarp height was measured on the DEM at several locations along the head scarp and the average height recorded. The height of each debris flow fan was measured on the DEM and is the difference in elevation from the bottom to the top of the fan (Figure 9). The slope was measured adjacent to each failed mass in order to estimate the pre-failure slope angle (Burns and Madin, 2009).

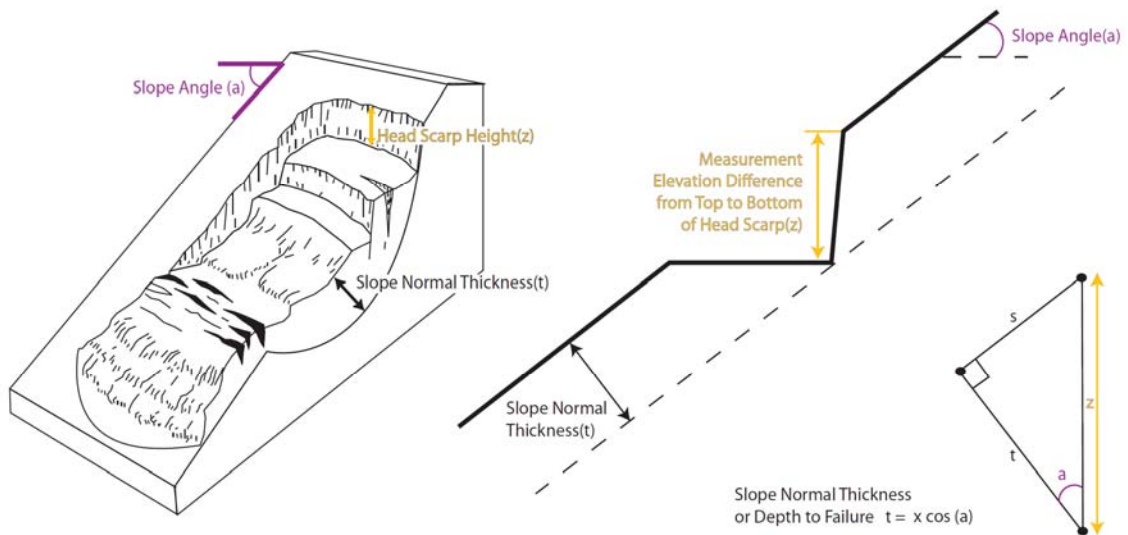
**Figure 10.** Calculation of estimated failure depth where  $t$  is failure depth;  $x$  is head scarp height; and  $a$  is slope angle in radians. The landslide inventory contains slope angles in degrees that must be converted to radians to calculate estimated failure depth (Burns and Madin, 2009).

Each landslide was then classified as deep- or shallow-seated based upon the slope angle and head scarp height (Figure 10). The equation used to estimate failure depth is:

$$t = xc\cos(a) \qquad \textbf{Equation 1}$$

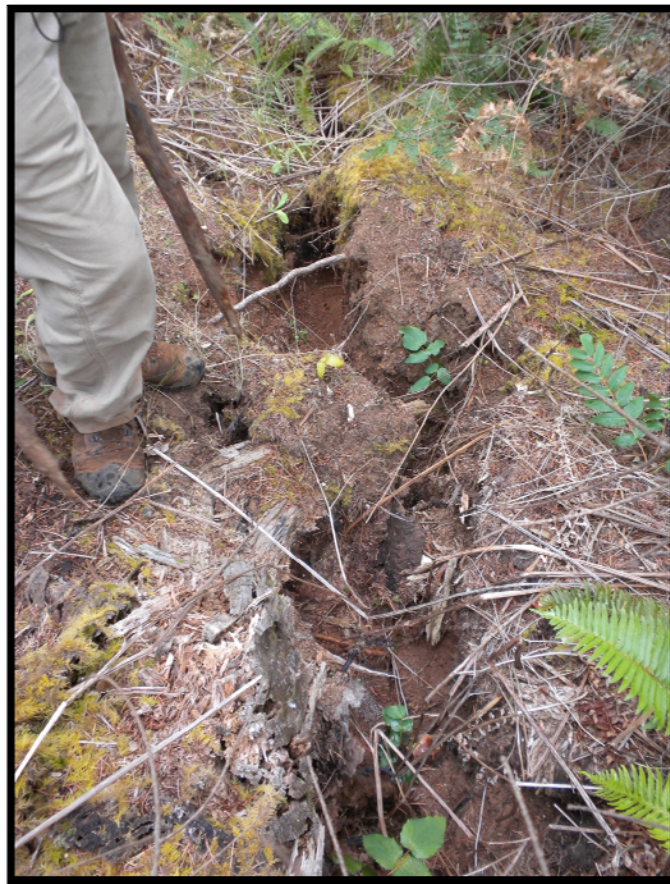
Figure 11. Transverse tension cracks on active landslide. Landslide number PC\_87.

The majority of the landslide inventory (81%) was field checked using a landslide inventory sheet. The landslide type of movement, activity, geology, landslide feature present (head scarp, flanks, internal features, toe), land-use, vegetation, and probable cause were recorded following Burns et al. (1998). On active landslides, the length, width, and scarp height also were recorded. Photographs were taken at each landslide deposit. Photographs of each landslide are not included in this thesis due to poor visibility in dense forest canopy. Landslides were identified based upon recognition of landslide features such as scarps, toes, hummocks, colluvium, bent trees, tension cracks, sag ponds, offset drainages, and mid-slope terraces (Figures 11-14).

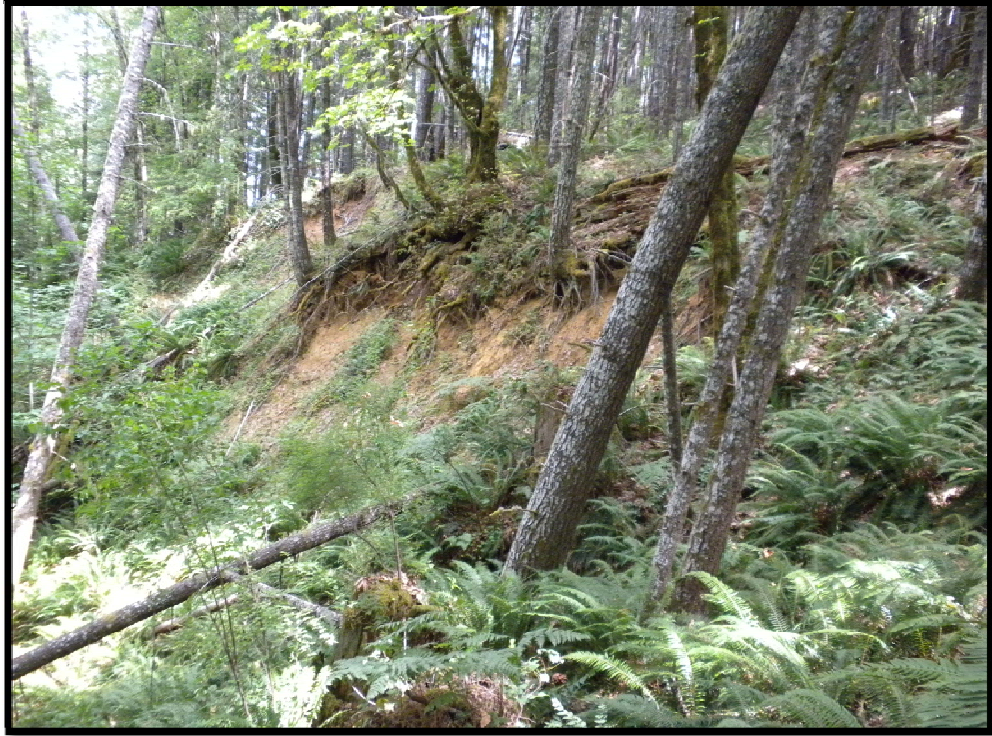
**Figure 12. Head scarp of the earth flow that silted the Carlton Reservoir in on May 7<sup>th</sup>, 1999. Landslide number PC\_50.**

Sediments from landslides and debris flows are of great concern in the Panther Creek Watershed due to their effects on water quality. On March 7<sup>th</sup> 1999, saturated, fractured parent materials created a slip plane that triggered a massive slide that flowed into the Carlton Reservoir (Worrel, 1999). The landslide initiated as an earth flow approximately 8 kilometers (0.5 miles) from the reservoir and mobilized into a debris flow unloading 45,000 cubic meters of material into the reservoir (Pointer, 1999). The landslide resulted in a 50% decrease in the reservoir's capacity, severely affecting the city of Carlton's 1,500 residents (Worrel, 1999).

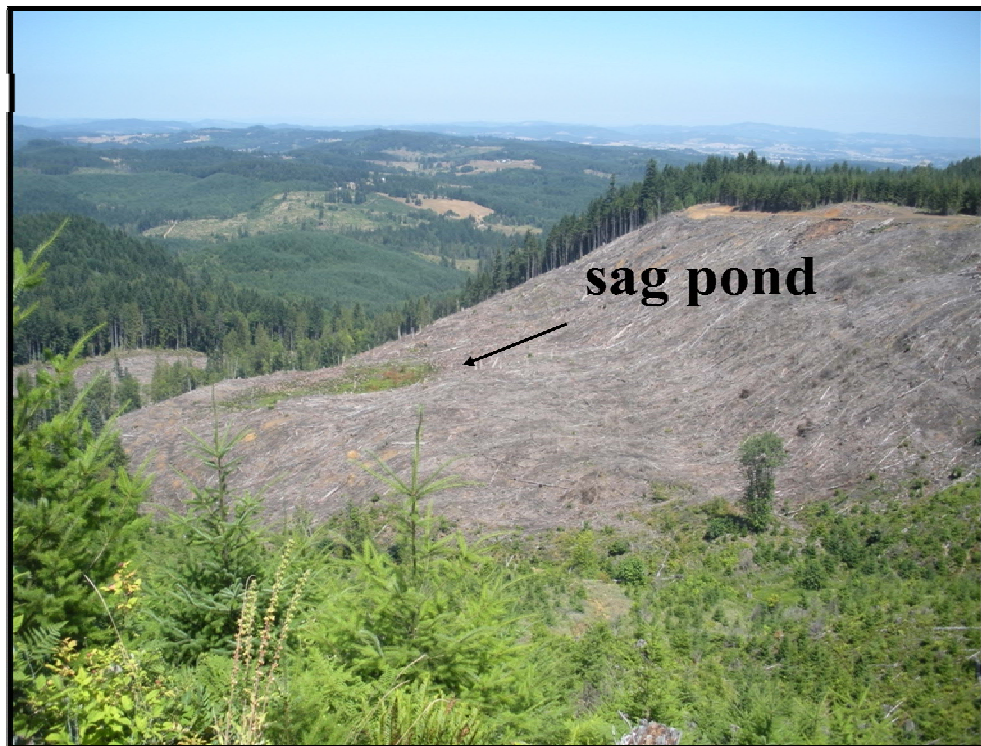
**Figure 13. Rotational landslide bench with accompanying sag pond. Landslide number PC\_71.**

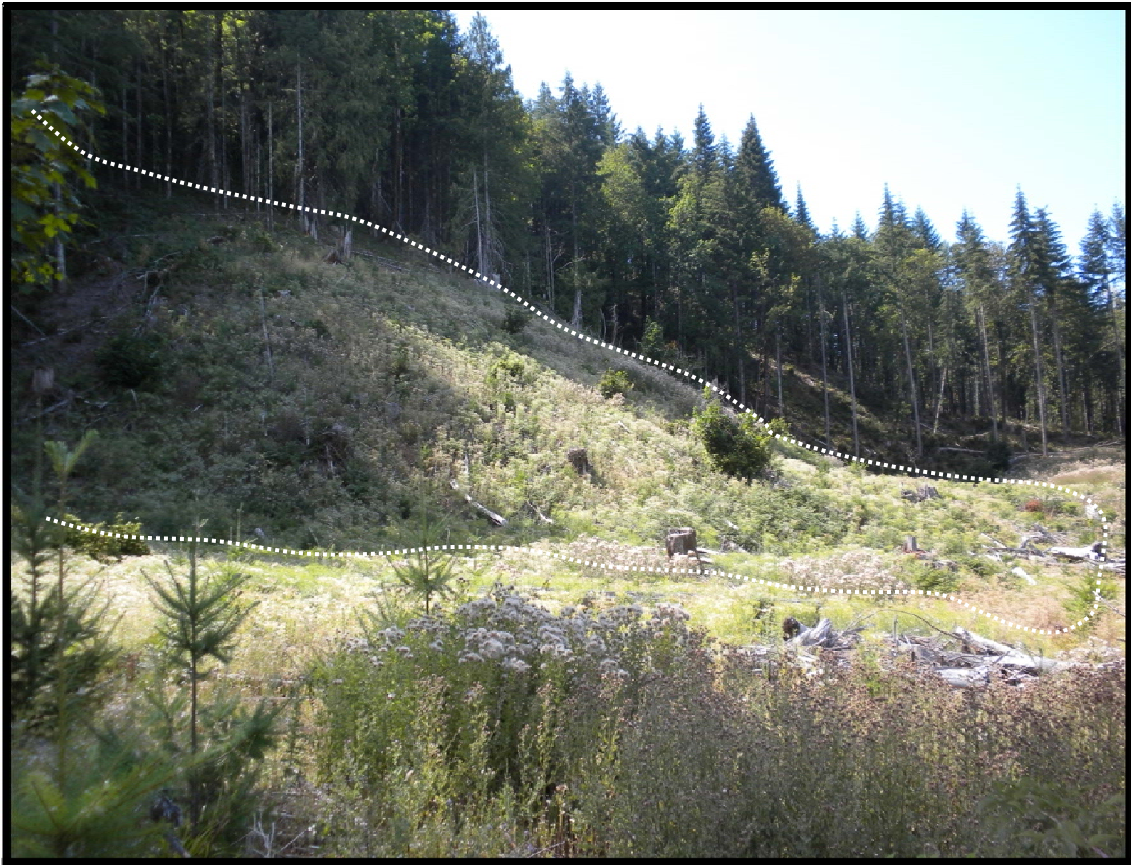
**Figure 14. Landslide toe of earth flow PC\_93.**

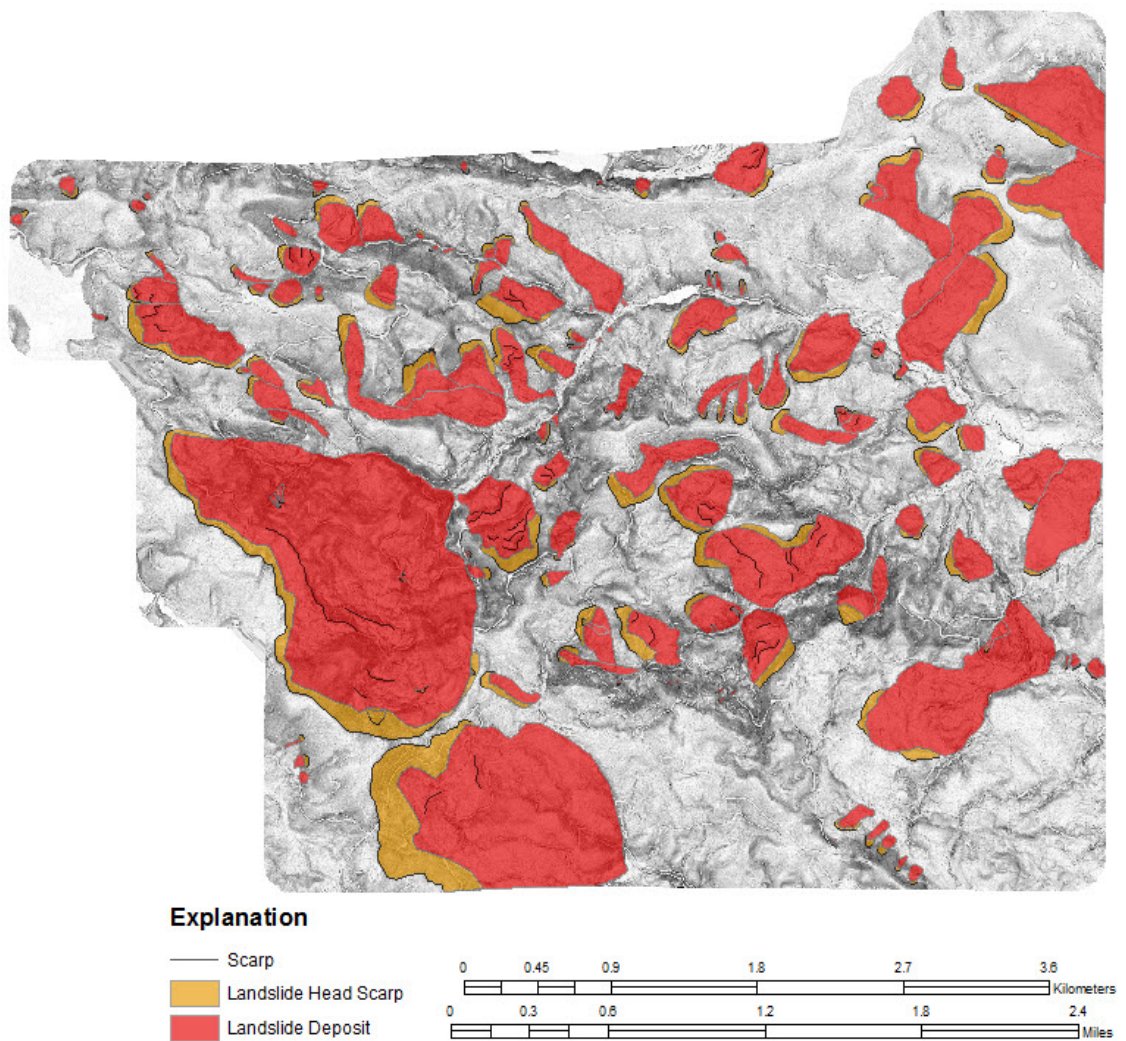
Figure 15. LiDAR-based landslide inventory for the Panther Creek Watershed, Oregon.

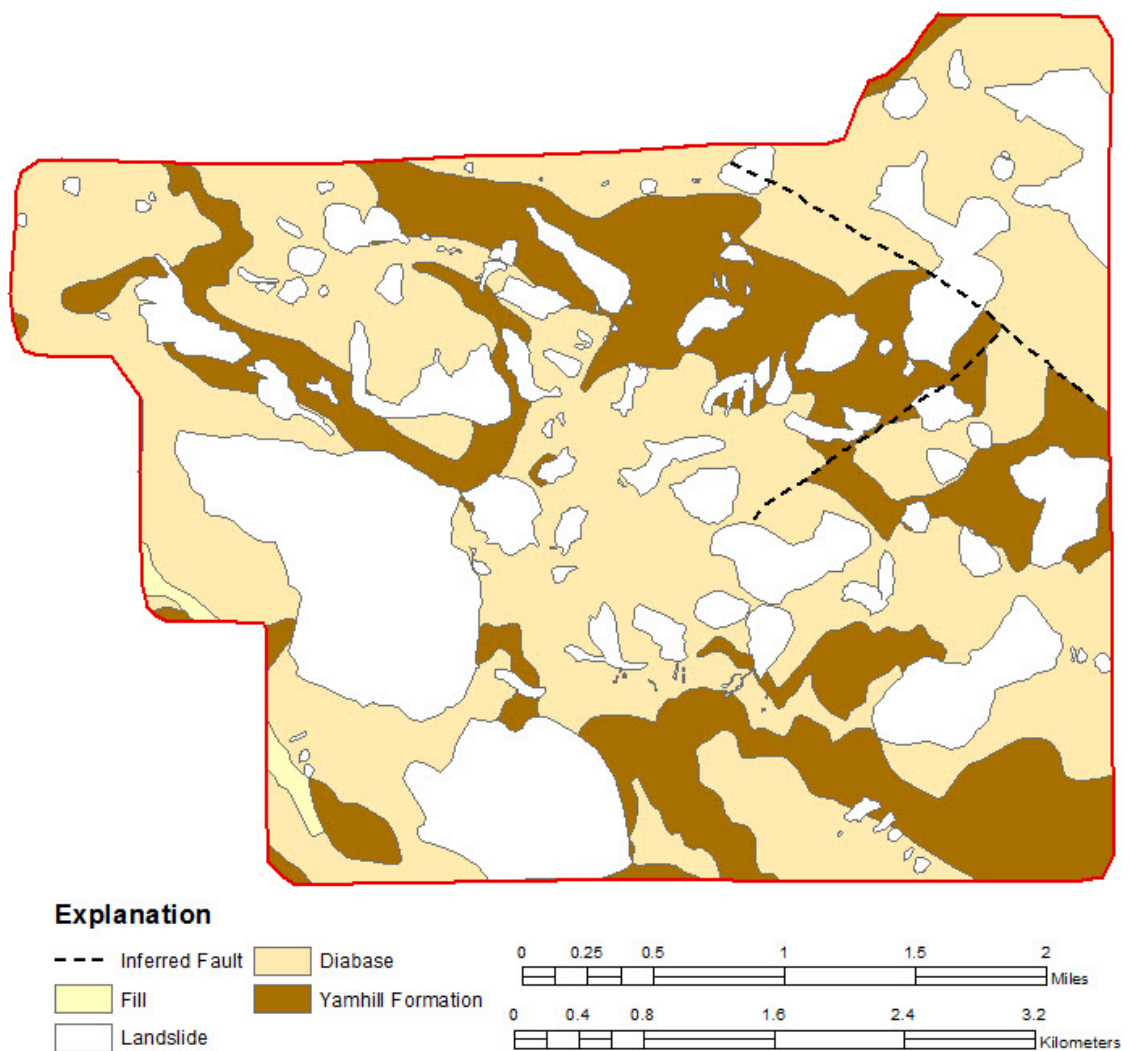
**Figure 16. New geologic map modified from Wells et al. (1994) based on LiDAR-based landslide inventory.**

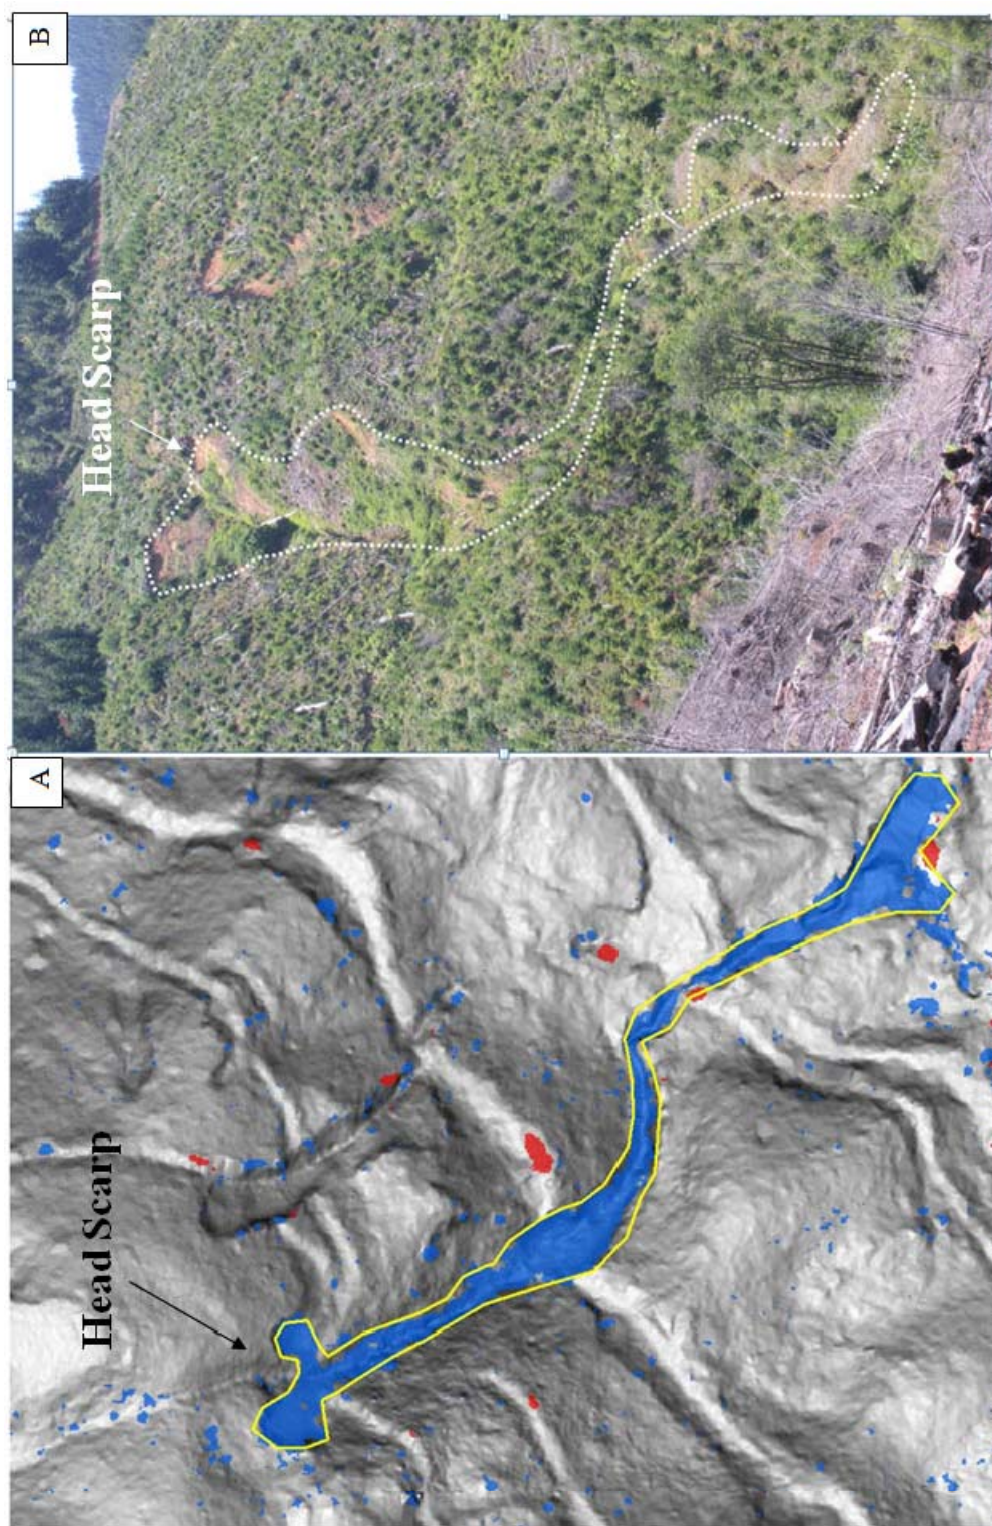
Figure 17. (a) December and September 2007 differential dataset with active debris flow (PC\_105) marked in yellow. (b) Field photo of landslide PC\_105.

Burns et al. (2010) found a total of 15 active landslides in the December and September, 2007 differential LiDAR dataset (Differential Dataset 1). An example of a debris flow that occurred in this time span and reported in Differential Dataset 1 is shown in Figure 17. The December, 2007 LiDAR was subtracted from the March, 2009 LiDAR to create Differential Dataset 2. A 0.5 m threshold was applied to map active landslides (Figure 18). Probable landslides were mapped based on contiguous positive or negative

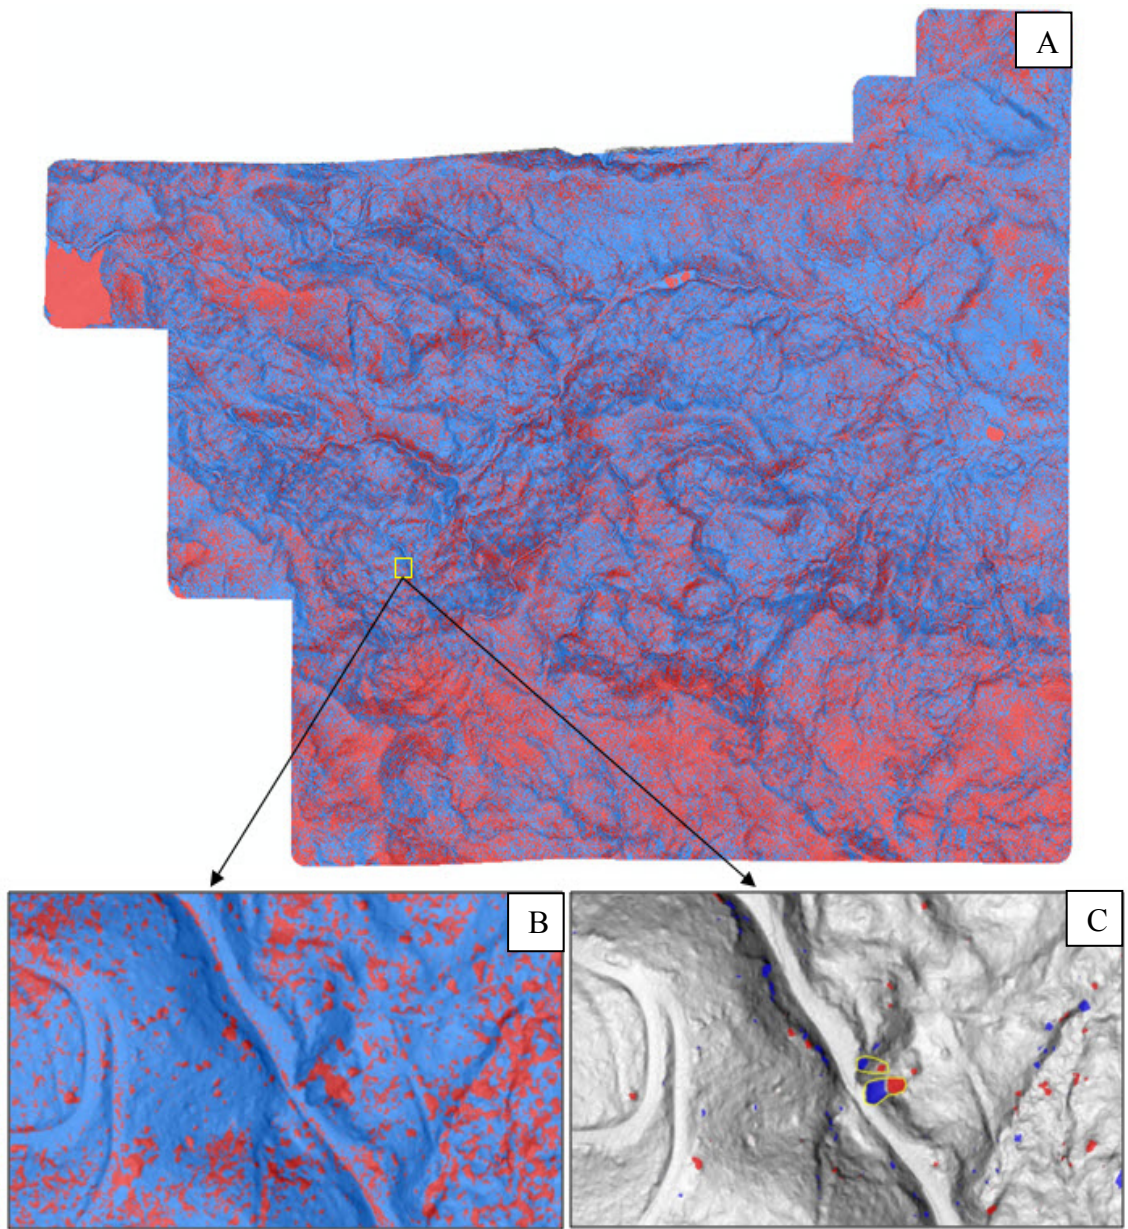
**Figure 18. Mapping landslides with differential LiDAR. Blue indicates a decrease in elevation and red indicated an increase in elevation (a) Initial subtraction of March 2009 from December 2007 LiDAR. (b) Inset of initial subtraction. (c) Inset after 0.5 m threshold was applied. Field verified active landslides are marked in yellow.**

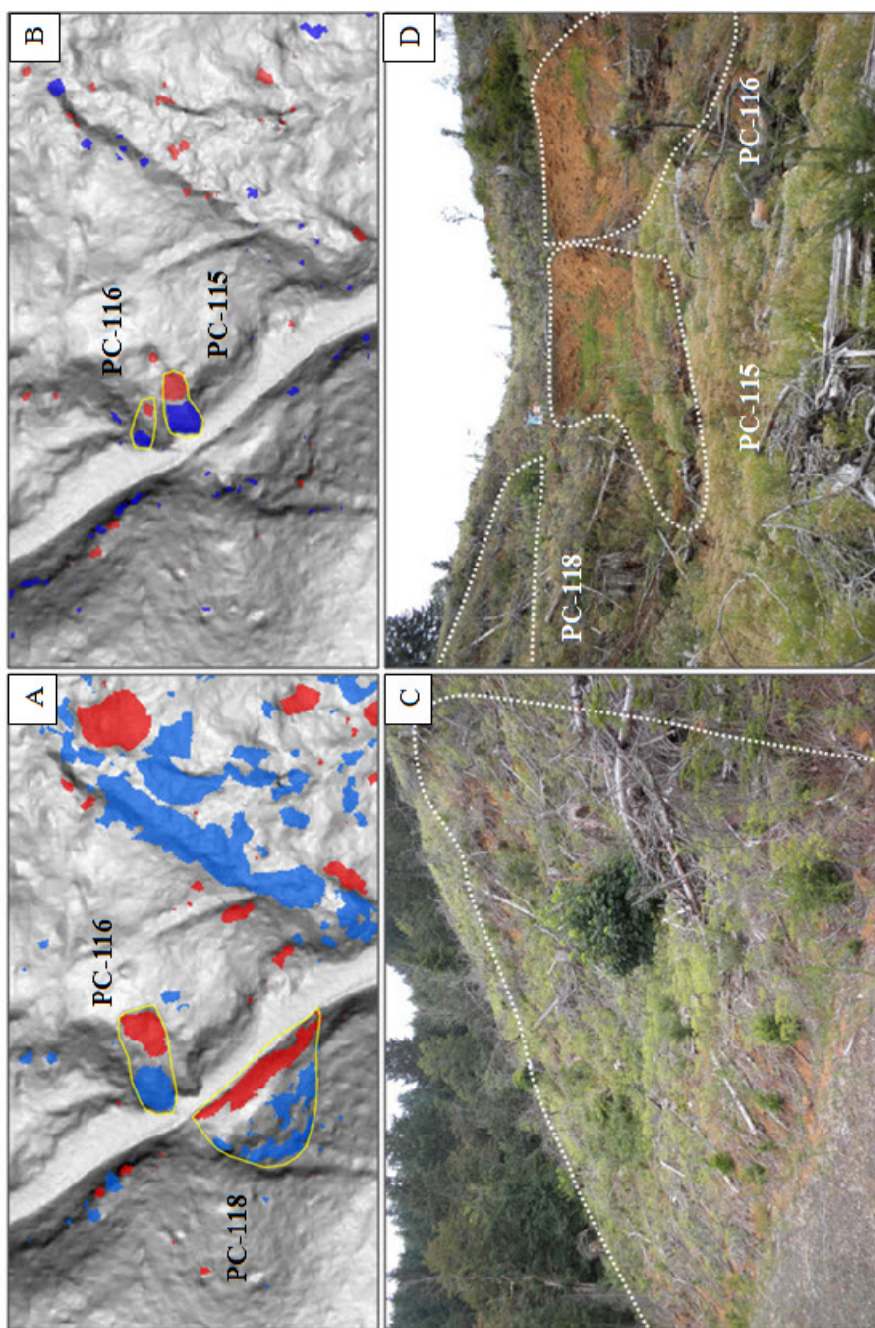
Figure 19. (a) December and September 2007 Differential Dataset 1 with active landslides marked in yellow. (b) March 2009 and December 2007 Differential Dataset 2 with active landslides marked in yellow at same location as picture a. Notice continued movement of landslide PC\_116. (c) Field photo of landslide PC\_118. (d) Field photo of landslides PC\_115, PC\_116, and PC\_118.

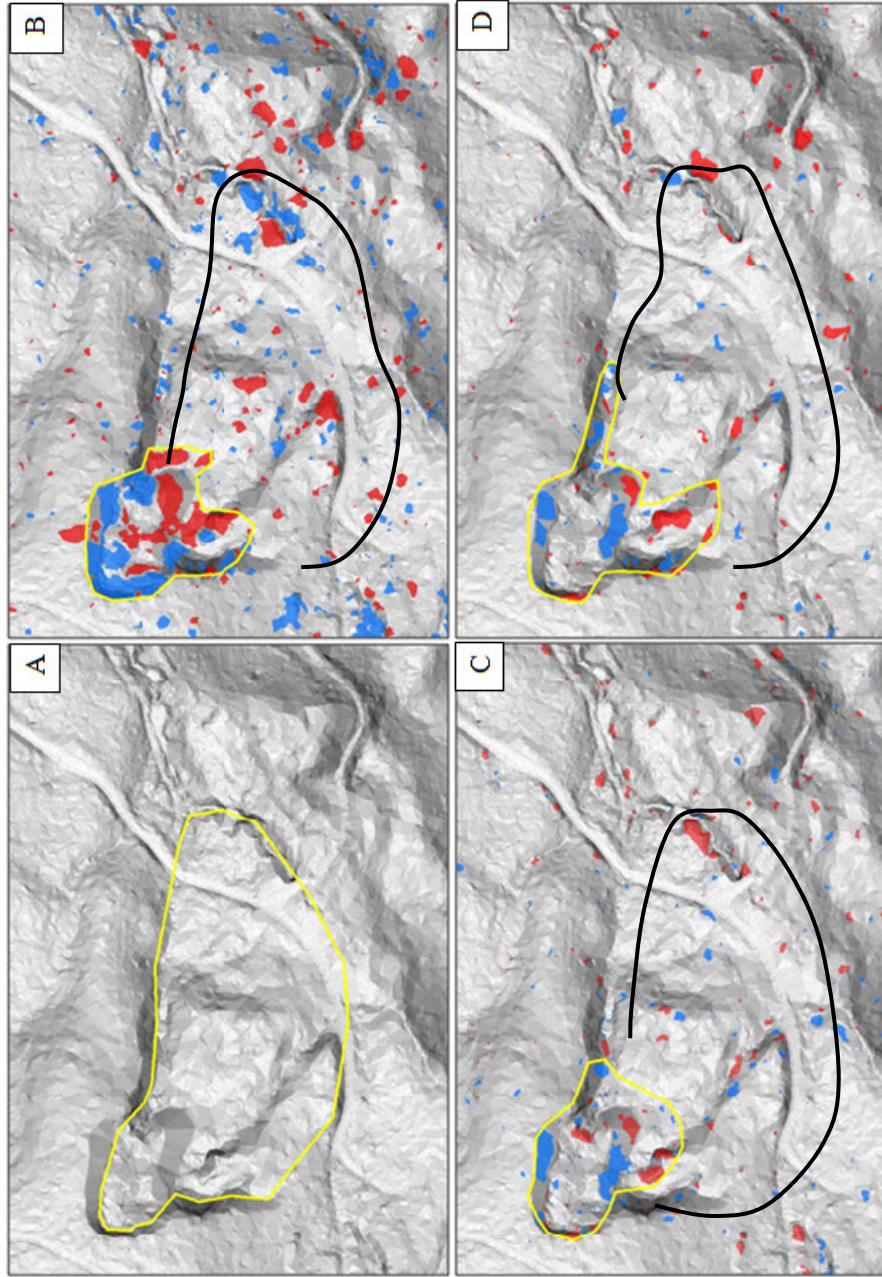
Figure 20. Capturing active movement from one landslide (PC\_156) over two differential datasets (a) Original mapped historic landslide marked in yellow. (b) December and September 2007 Differential Dataset 1 with active extent of landslide movement marked in yellow. (c) March 2009 and December 2007 Differential Dataset 2 with active extent of landslide movement marked in yellow. (d) March 2010 and March 2009 Differential Dataset 3 with active extent of landslide movement marked in yellow. All show greatest movement at the scarp and toe as mentioned by Burns, 1998a.

Differential LiDAR can also be used to track movement of a landslide through time. Landslide PC\_156 was originally mapped as a historic landslide deposit based upon its rougher appearance and with well-developed features such as cracks and scarps. The March, 2009 LiDAR was subtracted from the March, 2010 LiDAR to create Differential Dataset 3. Differential Dataset 1, Differential Dataset 2, and Differential Dataset 3 were used to observe current landslide activity at PC\_156. Significant movement of the head scarp is detected in Differential Dataset 1 (Figure 20). In the following two differential datasets the head scarp and upper minor scarp had continued movement.

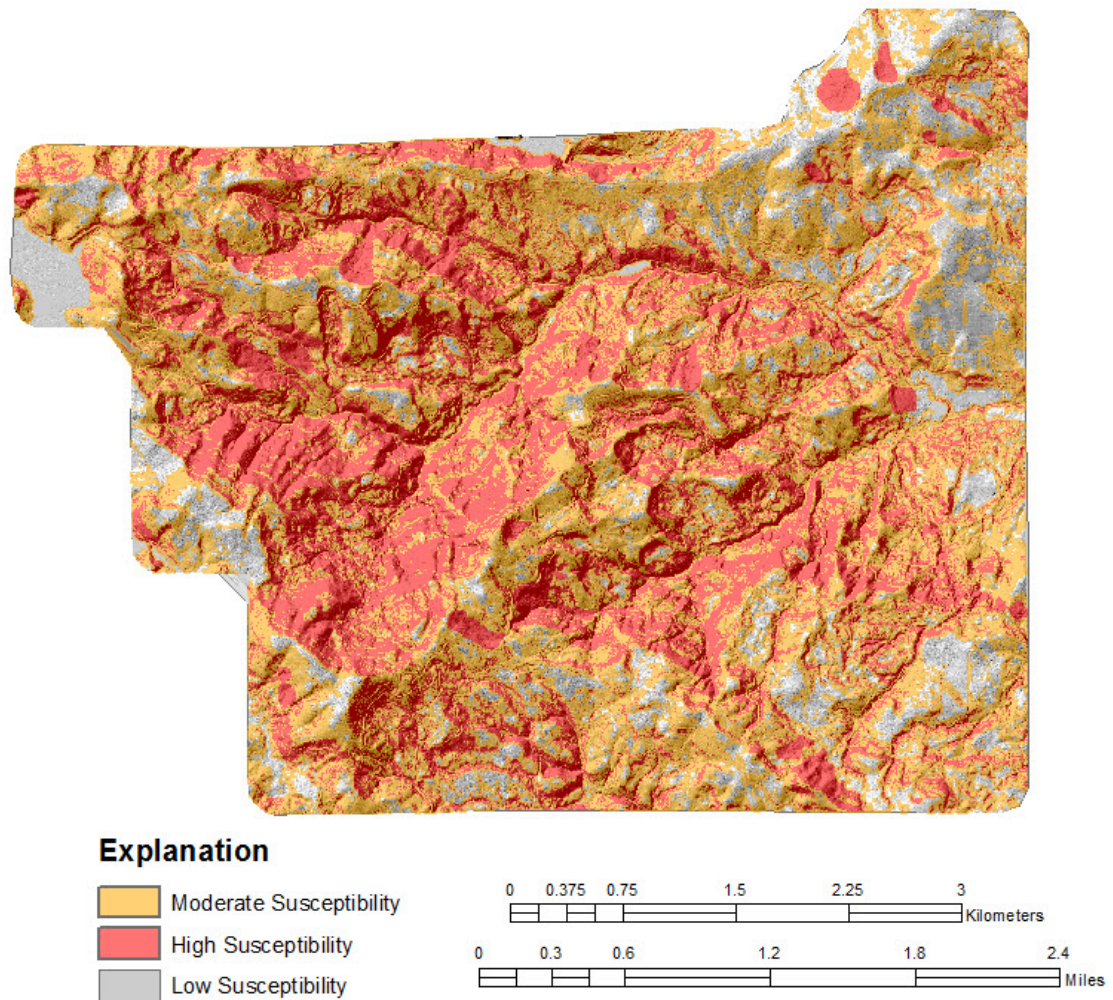
**Figure 21. Shallow-seated landslide susceptibility map of the study area displaying high susceptibility in red and moderate susceptibility in orange. Low susceptibility is in gray.**

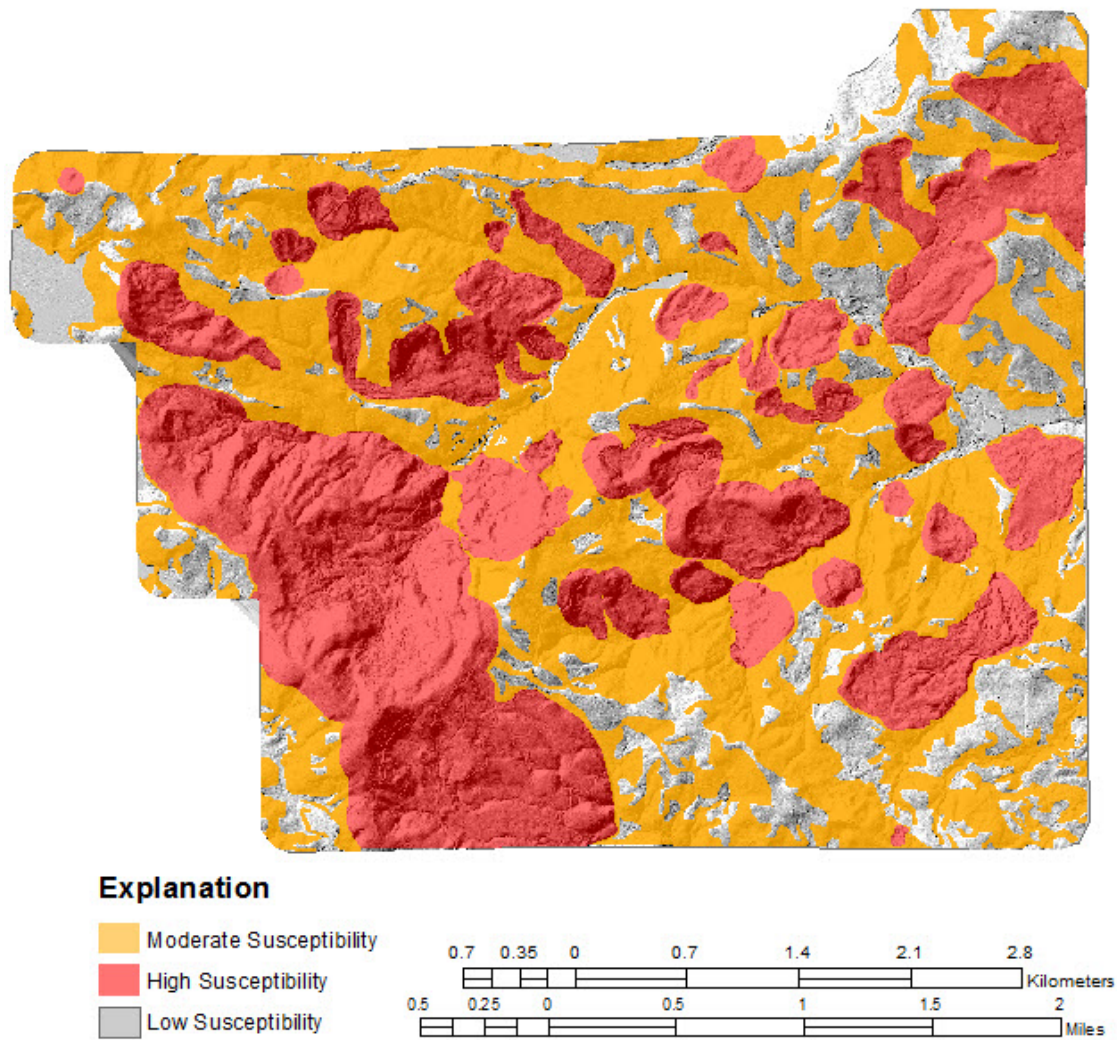
**Figure 22.** Deep-seated landslide susceptibility map of the study area displaying high susceptibility in red and moderate susceptibility in orange. Low susceptibility is in gray.

susceptibility zone covers 11.7 km<sup>2</sup> or approximately 43% of the study area. Only 19% of the study area is not susceptible to deep-seated landslides.

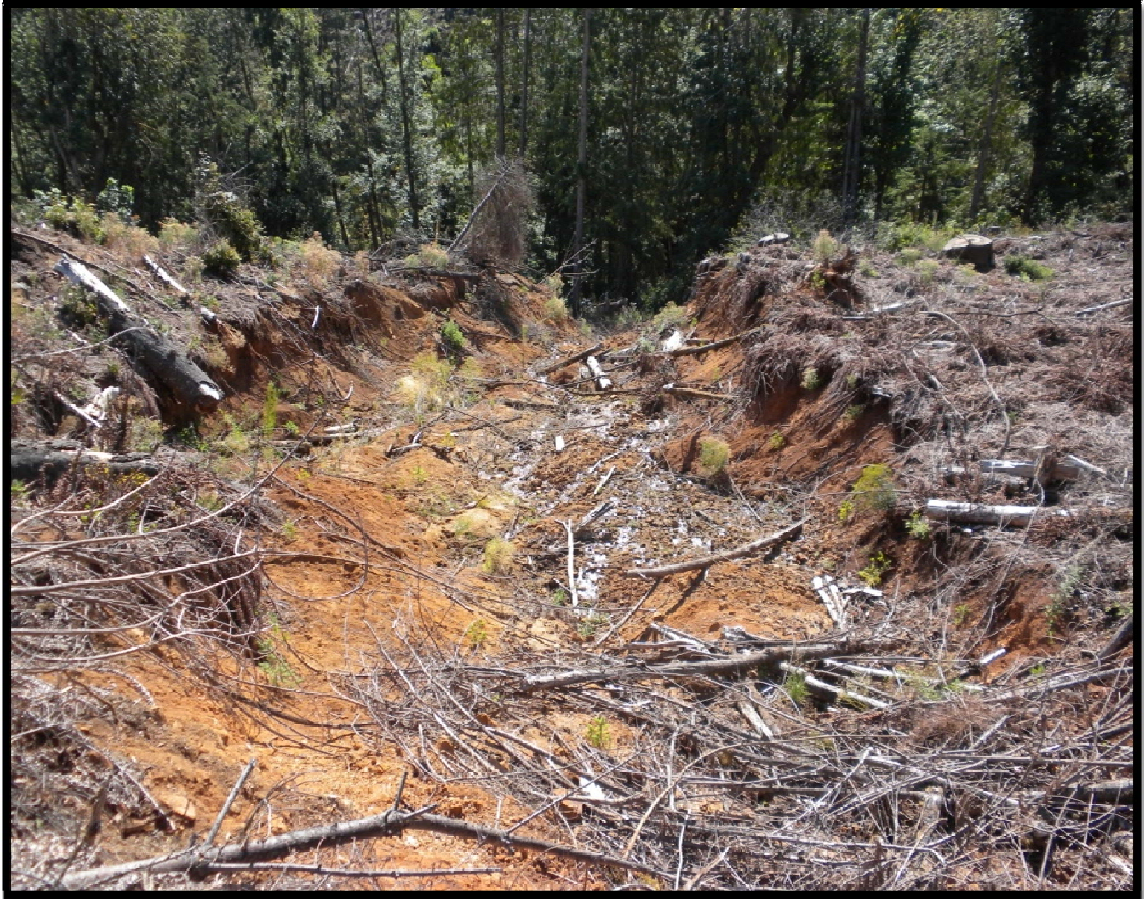
**Figure 23. Landslide PC\_104 that failed between September and December 2007 in a recently clearcut area.**

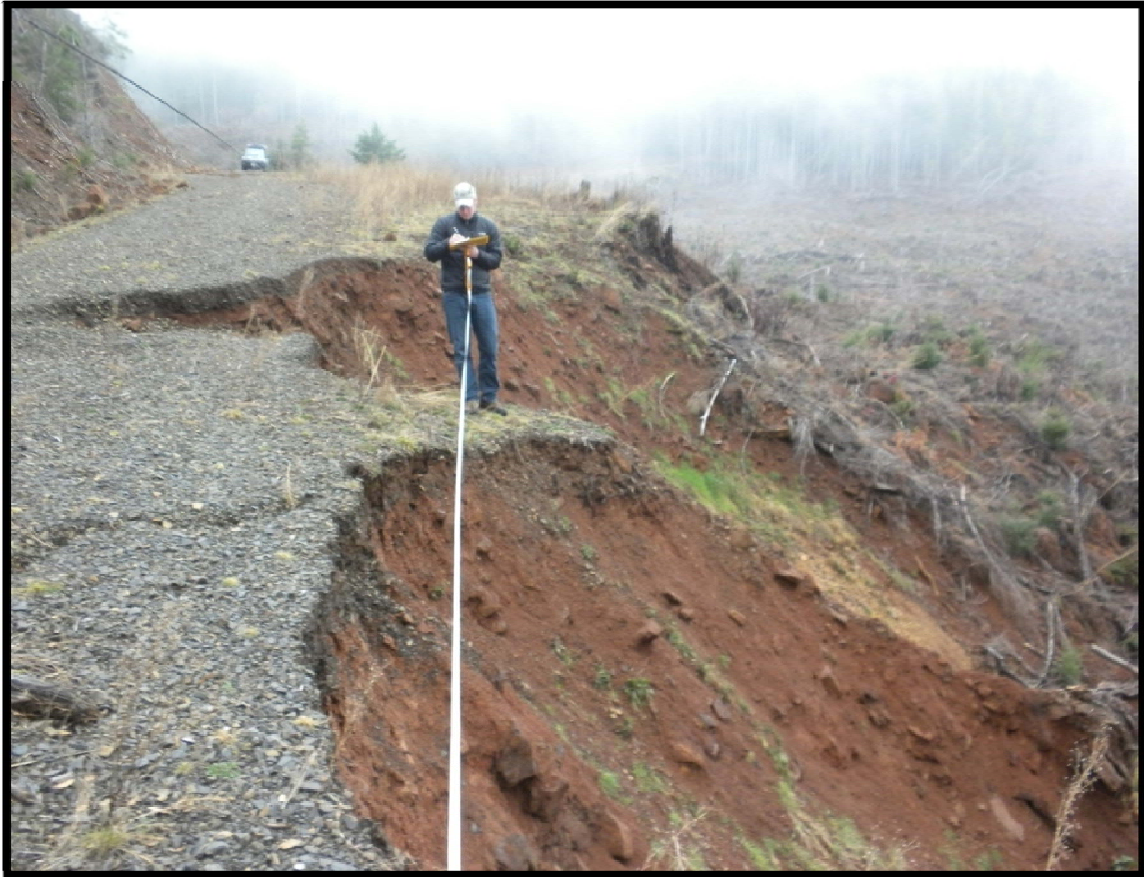
**Figure 24. Recent landslides (PC\_115 and PC\_116) failing along a logging road in a recently harvested area.**

The logging roads are commonly not engineered since they were predominantly built for temporary access to timber management areas. The remaining five recent landslides failed in unmanaged mature growth forest.
